# Maryland Historical Trust

## State Historic Sites Inventory Form

historic Frame house

Survey No. WA-III-085

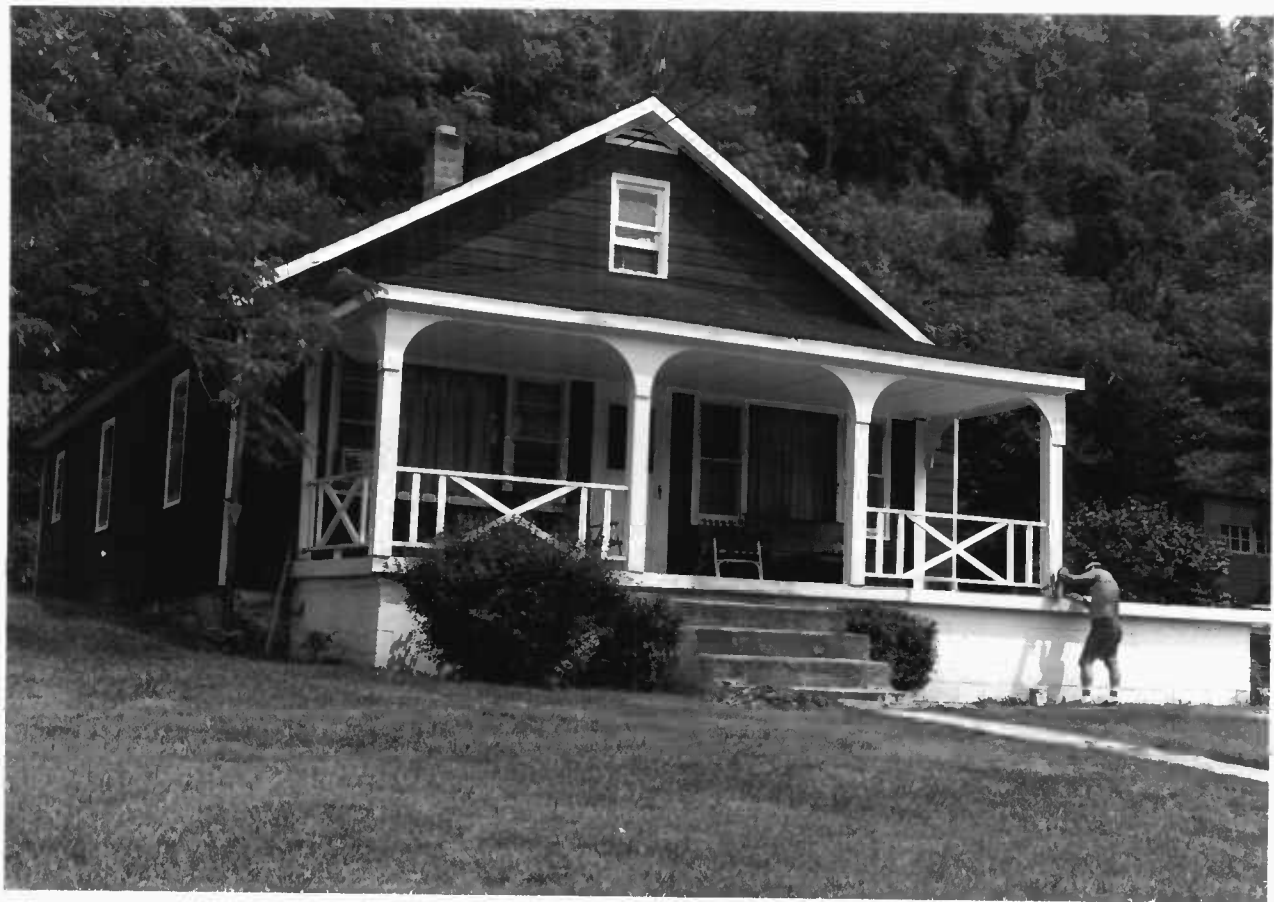
1. WA-III-085
2. Washington Co., Md.
3. Joe Getty
4. ~~April 1983~~ 7/82
5. Md. Hist. Trust, Annapolis, Md.
6. South elev. (camera facing north)
7. 1/1

The one-story structure is constructed of frame covered in a modern aluminum siding. The structure is built on a fieldstone foundation. The main facade is symmetrically arranged with a central entrance and a three-bay, one-story porch. On the outer bays of the first story are large three-section picture windows. In the gable is a one-over-one sash window. The porch sits on a concrete block foundation and has a stick railing, square posts, and curved brackets. The porch roof is hipped. The sides of the house have two-over-two sash windows in each bay. The gable roof has a boxed cornice and is covered in asphalt shingles. A concrete block chimney flue rises from the center of the structure.
